LEARNING FROM THE VANISHING BUILT HERITAGE
(A Case of Colonial Buildings in Abbottabad City-Pakistan)

METHODOLOGY ADOPTED FOR PROTECTION OF VANISHING BUILT HERITAGE**FRONTIER HOUSE
AND COMMISSIONER HOUSE
ABBOTTABAD****1.1. INTRODUCTION**

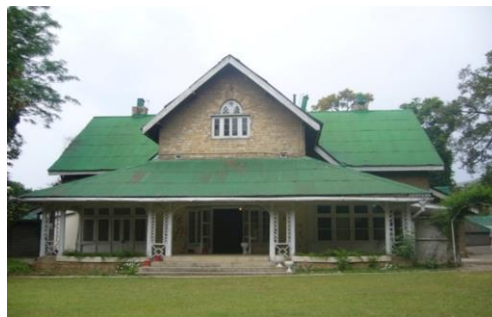
Fig. 1: Frontier House Abbottabad
Source: Author

Frontier House and commissioner House was among top priority in the list of built heritage to be conserved after the great earthquake 2005. Both houses are unique examples of British Era Architecture (Figure. 1 & 2). After the preliminary visual survey, a lot of cracks and material decay were identified.

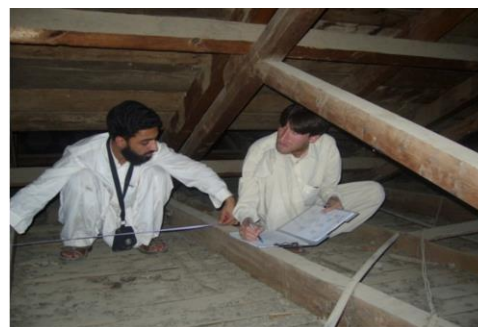
Fig. 3: Commissioner House Roof Inside
Source: Author

The visual survey of these two buildings is all done through the help of Heritage Architects (Student Volunteers). Every technical aspect of the buildings was checked during the condition survey to ensure the safety and authenticity of built heritage. The buildings were examined in detail. The Architectural and Archeological features were identified by Architects & Volunteers during the condition survey. Plans and sectional details, elevation, and roof details were documented during the survey as well as primary and secondary elements and technical aspects were studied to sort out treatment. (Figure. 3)

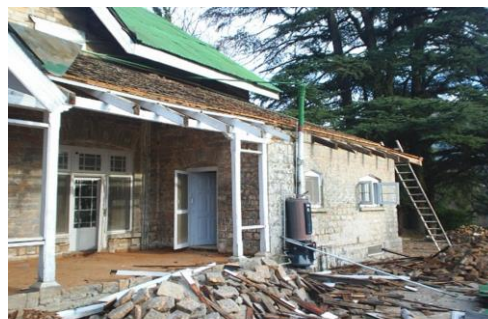
Fig. 4: Frontier House Back Side View
Source: Author

The next crucial step in conservation was to open the roof to identify the voids which later on might be become a serious problem in stormwater management. In the frontier house, the access was difficult to roof due to very worse condition of the roof because of dampness in wooden materials as the structure is surrounded by heavy tall trees around the buildings. The roof was repaired in its original condition with the help of experts. (Figure. 4)

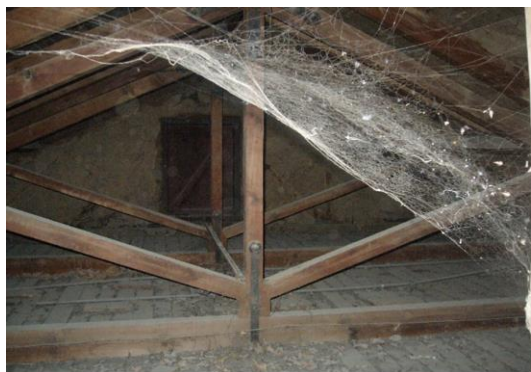
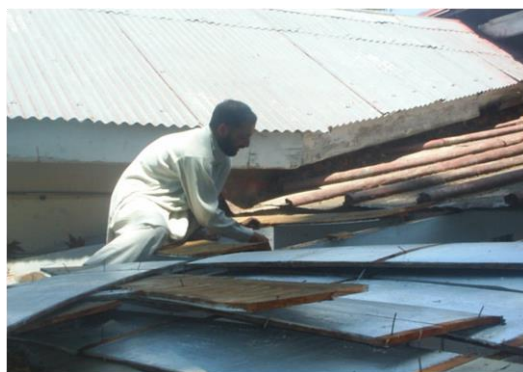
Fig. 5: Commissioner House Roof Inside
Source: Author

The assessment for the roof of these buildings was being made to identify the nature of damaged occurred due to the earthquake and weather condition. It was considered to accessing the roof details of the historical building and to sort out the possible solution for retaining its originality without taking any risk. (Figure. 5 & 6)

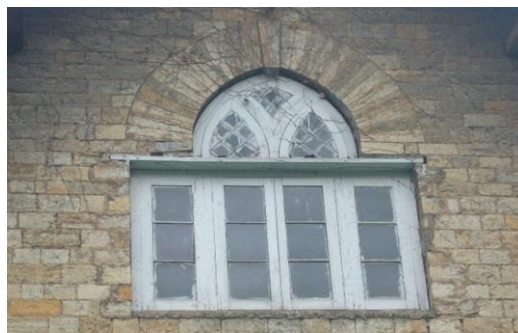
Fig. 7: Frontier House Window
Source: Author

For proper investigation of built heritage which is at stake, we were supposed to remove the herbs on the walls and its roof very carefully according to the experts' opinions and advice. While removing the finishing from the walls, proper consideration needs to be taken. In given figure (7) the window shown was completely damaged and due to the vegetation on the

wall surface, unnecessary plants were removed from the whole building to clean and secured from the further seepage and keep the originality of the buildings maintained. (Figure. 7)

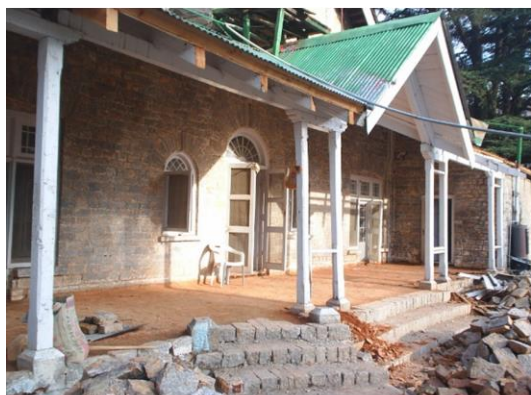
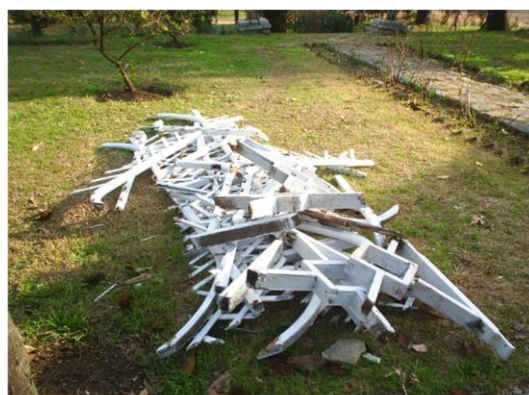
Fig. 15 & 16: Frontier House Back Side View and damaged wooden handrail
